# The Rupture of *Mont St. Hilaire*: Instrumental Analysis to Discover the Causes of Deterioration

Tasia M. Bulger – Art Conservation Program, Queen’s University, 2011

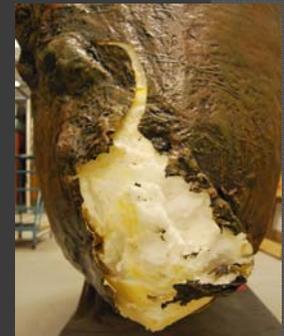
Fig 2. Detail of damaged area on sculpture

- Visual examination: unstable condition, flaking paint, abrasions, major area of detached resin coating
- Light microscopy: paint layer consists of two layers of paint over resin over a foam core
- FTIR: polyester styrene resin was used for the resin coating over a polyurethane foam
- XRF: paint layer is composed of mainly lead with traces of iron, chromium, cobalt, copper, and zinc

Visual examination and FTIR analysis concluded that absorption of water by the foam core had not caused the deterioration because the sculpture was composed of non-absorbent polyurethane foam. The cause of deterioration is likely the tendency for thinly-applied polyester resins to become brittle and form small cracks which allow moisture to penetrate and weaken the surface. It is recommended that the Agnes Etherington Art Centre monitor the deterioration of the sculpture as it is stable in its current environment, and that the sculpture not be returned to its previous outdoor environment. Should the sculpture undergo conservation treatment the area of loss and flaking paint should be stabilized. Possible materials which could be investigated further for eventual treatment are: polyester resin fixed over an inlay material, hide glue in Plextol D 540 in a 4:1 mixture with calcium carbonate, heating resin to reshape, and polyethylene ethafoam to replace missing polyurethane foam.

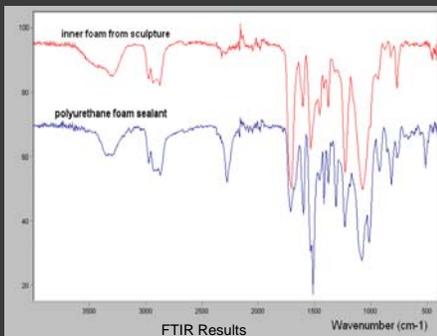
Fig 3. Foam from sculpture compared to a polyurethane foam.

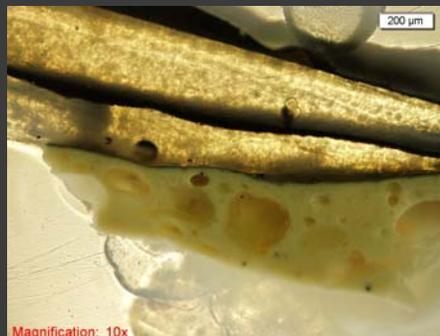
Fig 4. Cross-section of paint layers and foam under reflected light microscopy revealing layers consisting of paint, resin, paint, resin, paint, and foam.

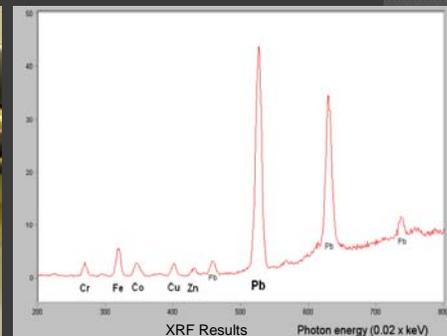
Fig 5. Paint layer contains high amounts of lead and trace amounts of chromium, iron, cobalt, copper, and zinc.
