## Investigation of Pink Staining on

# Marble Sculpture at the J. Paul Getty Museum

by Allison Lewis and Monica Ganio

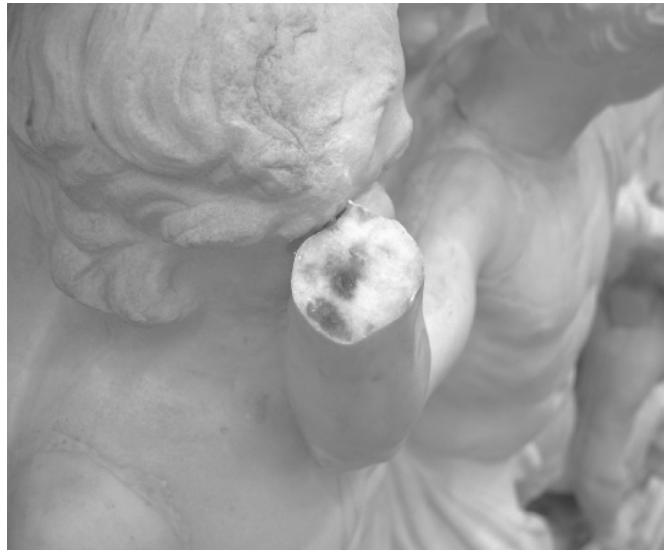
During the 2008 conservation of four marble sculptures in the antiquities collection at the J. Paul Getty Museum (JPGM), localized bright pink discoloration in association with a brownish, slightly rubbery adhesive was observed on join surfaces. (Figure 1) All four objects had been treated sometime in the 1970s with unknown materials, including undocumented adhesives.

Figure 1. Pink staining on the join surface of JPGM 78.AA.61.

While retreating the sculptures in 2008, JPGM conservators encountered pink discoloration already present on join surfaces and observed its active formation. Upon the introduction of deionized water and polar organic solvents, the pink material became very mobile, and in some cases bled to the exterior surface of the stone and newly applied fill material.

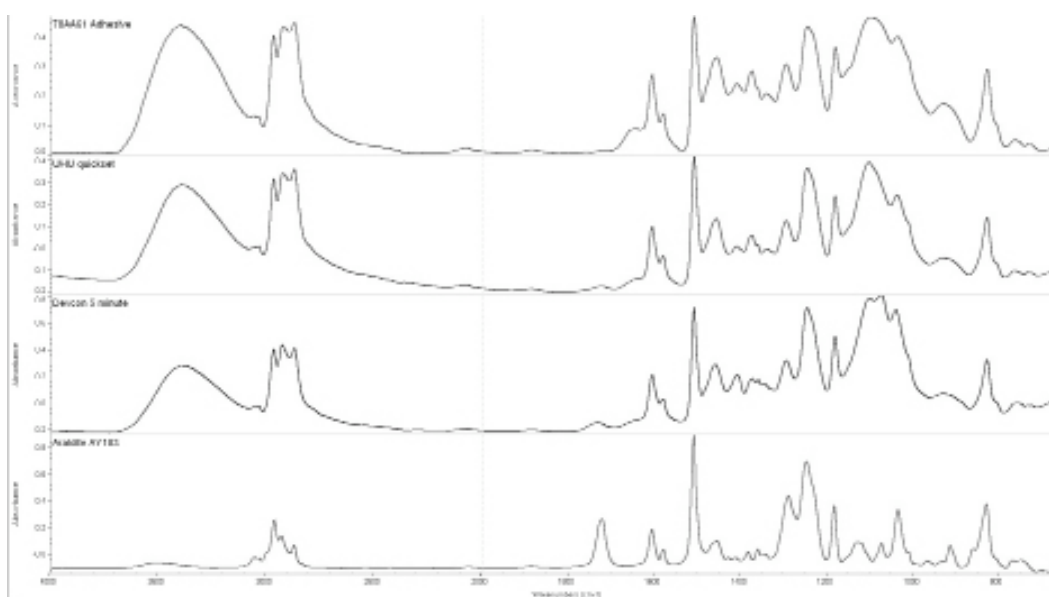
FT-IR confirmed that the adhesive associated with the pink discoloration is an epoxy and that the same epoxy was used on several of the marble sculptures. The analyses showed a very good match between the samples and UHU plus quickset and Devcon 5 minute epoxies from the 1988 GCI reference board, suggesting the use of a rapidly setting epoxy.

Figure 2. FT-IR spectra of:

pink-stained adhesive from JPGM marble sculpture 78.AA.61

UHU plus quickset epoxy (applied 1988)

Devcon 5 minute epoxy (applied 1988)

and Araldite AY 103 epoxy (applied 2009).

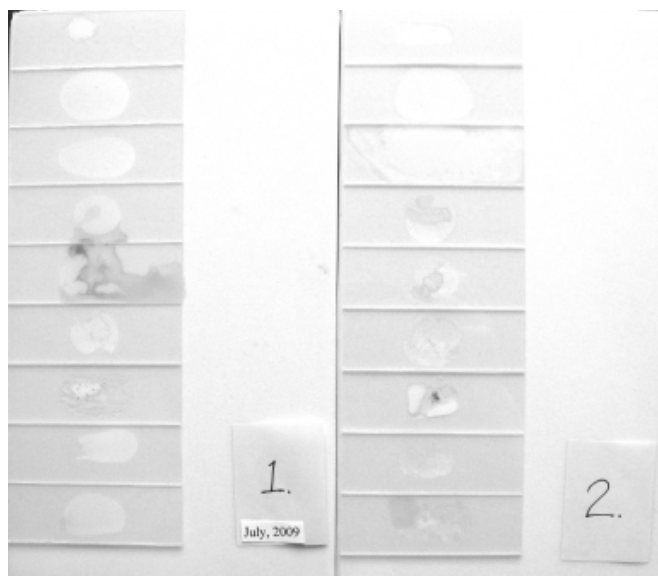
Pink staining developed in two locations on the experimental marble pieces over a period of four months. In both instances, pink discoloration appeared on the marble surface adjacent to new UHU plus quickset that had been cured at elevated relative humidity. On the board which had been

Figure 3. Experimental marble boards 1 (control) and 2 (cured at elevated relative humidity) four months after the application of UHU plus quickset epoxy. Faint pink discoloration formed on board 2, slide 3, the site of UHU plus quickset with excess hardener.

prepared at near 100% relative humidity, a faint pink halo appeared around the application of 1:3 binder: hardener (v: v) UHU plus quickset, the excess hardener formulation. No other pink staining appeared on any of the marble boards.
