Natasha K. Loeblich

Winterthur / University of Delaware

Collaborative Efforts for Paint Analysis: Two Opportunities for Technical Examination of Major Works in Tandem With Outside Institutions

Technical study of Interior Finishes in the William Byrd, III House at Colonial Williamsburg

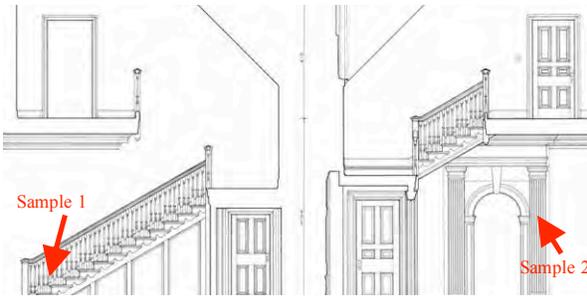
Figure 3: Center passage elevation; HABS Colonial Williamsburg Project, 1976.

In order to get more detailed information about the layers I turned to scanning electron microscopy with energy-dispersive spectrometry (SEM-EDS) and transmittance FTIR analysis which I applied towards some of my more interesting samples with early layers and complex stratigraphies. The first sample was taken from the edge of a banister on the staircase in the Central Passage, as shown in Figure 3.
