A New Approach to Cleaning Iron-Stained Marble Surfaces

This paper was first presented at the 2006 Annual Student Conference of the Association of North American Graduate Programs in the Conservation of Cultural Property, hosted by the University of Delaware/Winterthur Art Conservation Department.

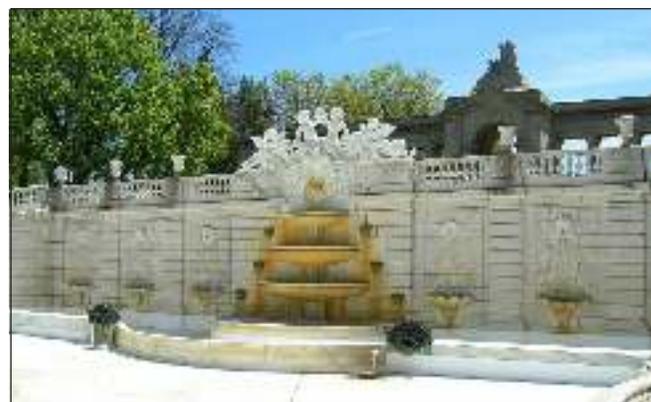
Figure 1. Iron-stained marble fountains at Nemours

A real-life example of a staining problem, and the impetus for much of this research is the grand fountain at Nemours, the site of a former 300-acre estate of Alfred I. duPont (Figure 1). The fountains are part of the Louis XVI-style garden on the estate just outside of Wilmington, Delaware. Several marble and other stone sculptures and architectural structures are placed throughout the gardens. At the time of this writing, Nemours has embarked upon a two million dollar restoration project that includes the cleaning of the marble fountains, which have been in use since 1911. The original plan was to use commercially available stone cleaning preparations to remove the staining with the intent of returning the fountains to working order soon thereafter.

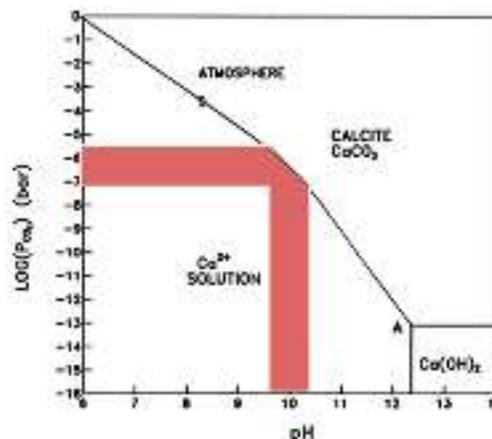
Figure 2a. Calcite saturation as a function of pH and P_{CO_2}

mospheric concentrations, the dissolution of the calcite is favored at a pH below about 8.3. However, if a poultice or a gelled preparation is used to clean the surface, the partial pressure of CO_2 at that surface is reduced. As the partial pressure of CO_2 decreases, the amount of calcium going into solution reaches a minimum around a pH of 10 (Figure 2). Since using a poultice or gel is probably unavoidable in these situations, working at a pH near 10 should help to minimize the amount of damage possible to the marble surface.

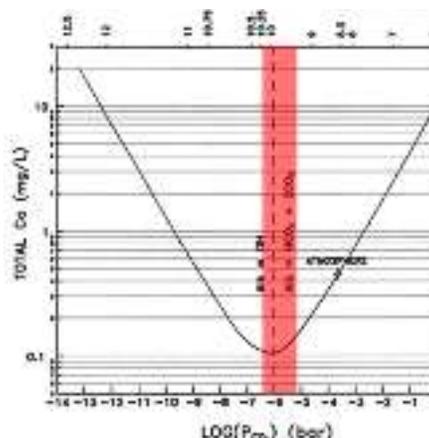
Figure 2b. Calcite saturation vs. CO_2 pressure. The highlighted regions represent conditions of minimum solubility at decreased carbon dioxide concentration. (Figures adapted from Livingston, 1992.)

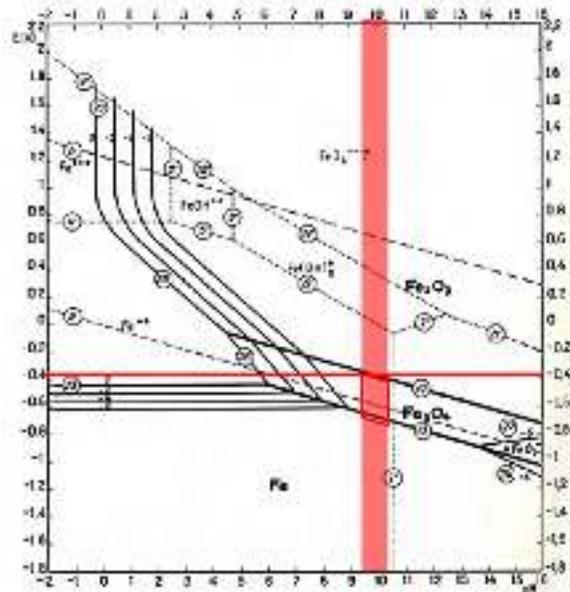
Figure 4. Pourbaix diagram for an iron-water system. The highlighted region denotes the pH range determined before, and the horizontal line at around -400mV marks the point at which formation of iron(II) species is favored.

Looking at a Pourbaix diagram showing the relationship between speciation, pH, and electrical potential for an iron-water system, it is possible to see how insoluble iron(III) can be reduced to iron(II) (Figure 4). For a solution at a pH of 10 with an oxidation-reduction potential of zero millivolts, the dominant form of iron shown here is Fe₂O₃. Given the pH range determined before, if one can get close to providing a reducing potential of 300 to 400 millivolts, we will begin to reduce some of the iron(III) to iron(II).

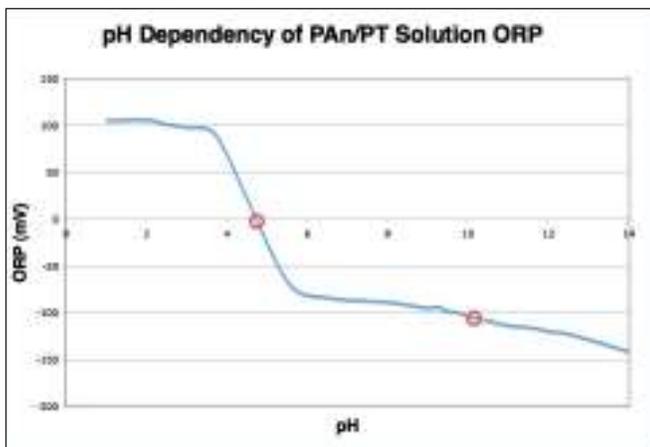
Figure 5. pH dependency of PAN/PT Solution ORP

The plot in Figure 5 shows the pH dependency of a polyaniline and polythiophene solution's oxidation-reduction potential. Around pH 5, the solution changes from an oxidizing potential to a reducing potential. Also of note is that around a pH of 10, the potential begins to decrease more rapidly. While the ORP of this test solution reached between 100 and 150 millivolts of reducing potential, in final preparations and under UV light as in outdoor conditions on a sunny day, a reducing potential of around 270 millivolts was achieved. While this is shy of the desired value of near 400 millivolts of reducing potential, it should create a condition where some of the available iron(III) would be reduced to iron(II).

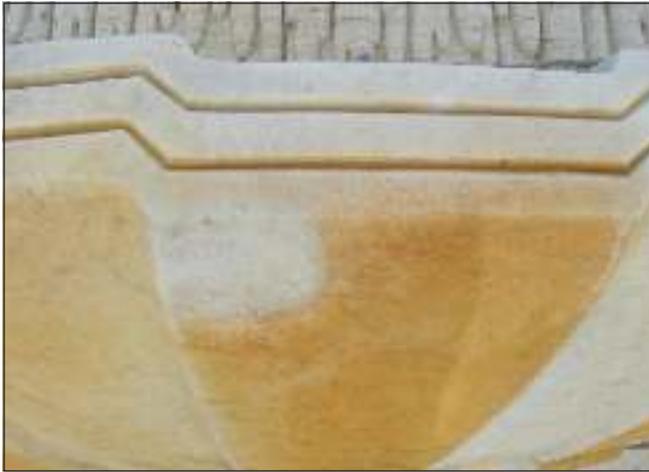
Figure 6. A test cleaning after two minutes of gel application

In testing the cleaning solution, it became clear that the ability to remove staining depended greatly upon the availability of iron and the depth of stain penetration. Where iron is readily available close to the surface, the cleaning system works very well and efficiently, taking on the order of only 1 to 2 minutes for stain removal (Figure 6). The cleaning formulation allows some degree of "tuning" in that a number of variables can be manipulated to achieve the desired effect. Chelator and polymer concentration, duration of application, and exposure to light can all be easily adjusted.

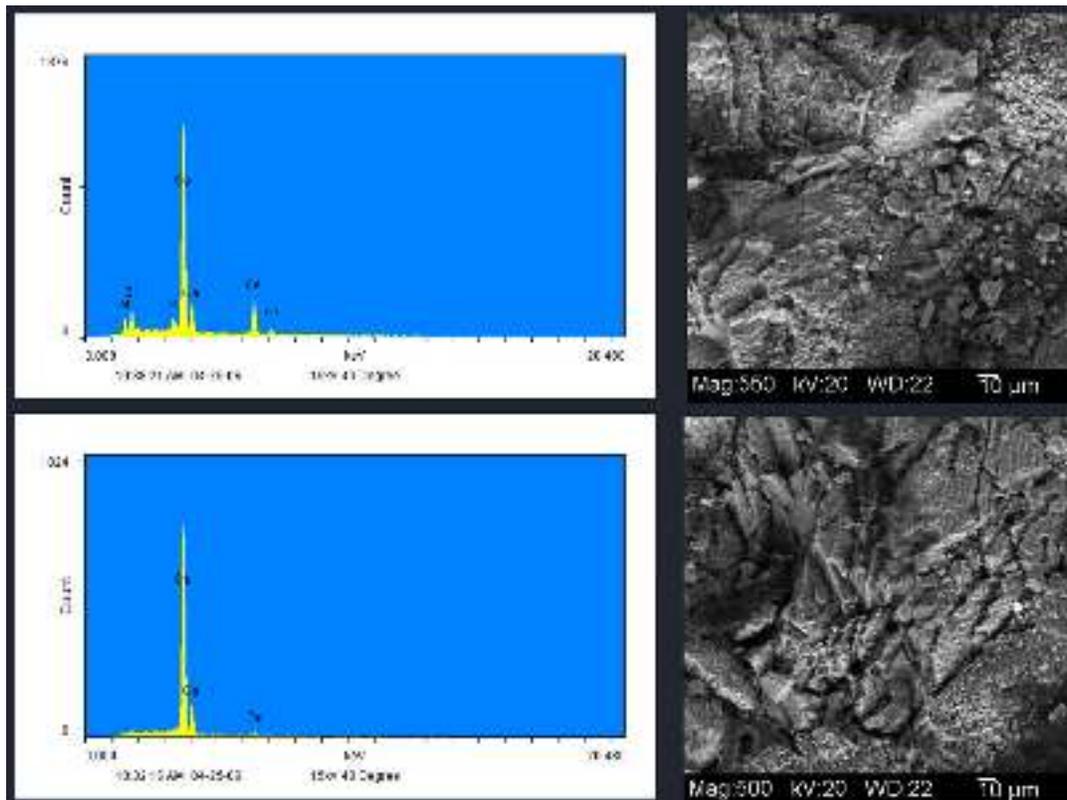
Figure 7. SEM-EDS spectra and secondary electron images for uncleaned (top) and cleaned (bottom) areas of an iron-stained architectural marble fragment

The secondary electron images suggest that little has changed on the marble surface after cleaning other than the removal of small surface particulate and perhaps some minor exfoliation.

Stained samples of marble were examined before and after cleaning using SEM-EDS (Figure 7). The important features to note here are the differences in the peak height ratios of calcium and iron between the uncleaned and cleaned areas. It is also important to note that the surfaces do not appear to be too morphologically dissimilar in the secondary electron images.
